## Resistance of Components to Zinc Plated Against Corrosion

**Abstract:** In the article we focused on the zinc coating by galvanic zinc coating on the surface of the material for its corrosion resistance. The introduction deals with theoretical knowledge such as material selection, processing, cleaning and surface protection. The next part is devoted to the measurement of the coating thickness using an X-ray machine and corrosion test methods. The article methodology deals about galvanic zinc technologies in the acid bath as well as the technological process itself, the coating thickness tests using the Fisherscope X-RAY XDL-B X-ray apparatus, the coating thickness measurement procedure and the salt spray corrosion test in the Liebisch Labortechnik SKB 1000 AT-R corrosion chamber. The results of the work show the table and the graph of the results of the coating thickness measurements and the evaluation of the corrosion test.

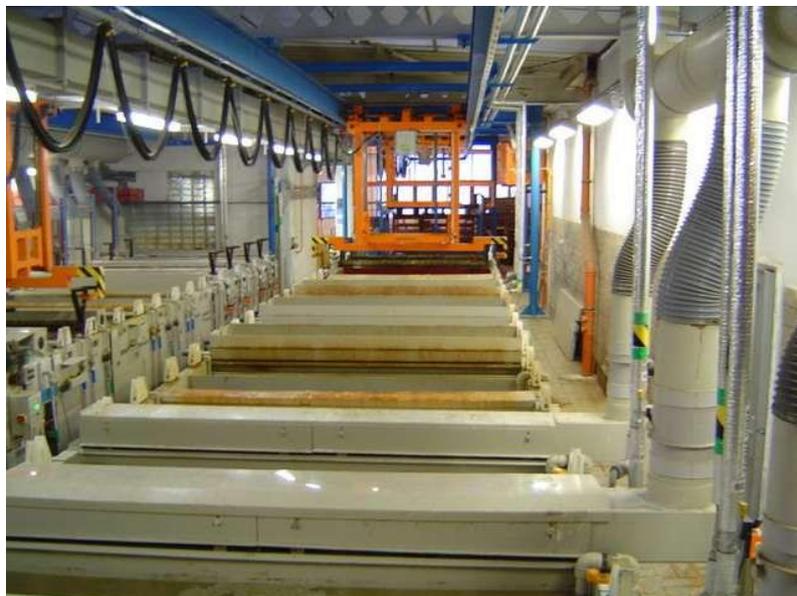
**Fig. 1** Galvanizing line

Typical representatives of these impurities are hydrated oxides (rust). The action of these strong acids leads to a chemical reaction to form soluble salts (Fig. 1). Most often, the steel is pickled in sulfuric acid or hydrochloric acid. The next step is to re-create the two-stage cold rinse with service water. This is followed by electrolytic degreasing, which is responsible for the highest quality degreasing of the material, so it is placed at the end.

The actual electrolytic zinc process is carried out in an acid bath. The bath consists of an aqueous solution of potassium chloride and dissolved zinc. Another additive is boric acid to stabilize the pH of the bath. The acidity of the bath must be between pH 5 – 5.5. This operation is only followed by operations that provide a higher surface quality. One of them is a thick layer passivation, which aims to increase the corrosion resistance of the coating. The passivation is followed by rinsing with cold water and warm air drying. The last operation is the hanging from the hinges and the storage of the parts in the shipping pallets [6].

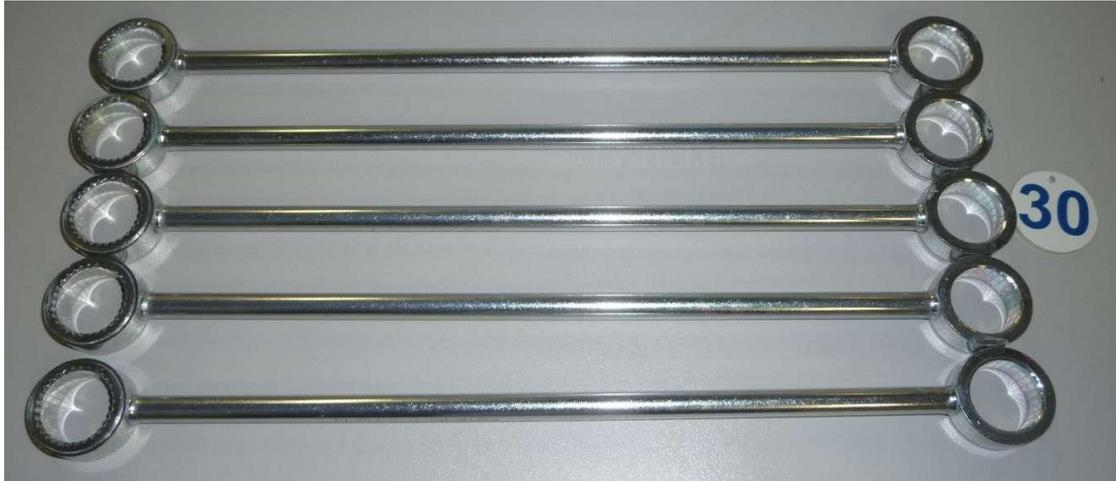
**Fig. 2** Test samples after 240 hours

The corrosion test was performed in the Liebisch Labortechnik corrosion chamber of the SKB 1000 A-TR type. The procedure of the corrosion test was made according to the standard STN EN ISO 9227, which talks about corrosion tests in artificial atmospheres and salt fog tests. Five random samples were tested for corrosion testing. The customer has determined the thickness of the coating and the corrosion resistance of the components. The zinc thickness of the components should be in the range of 11-22  $\mu\text{m}$ , which all randomly selected samples met. The required corrosion resistance to white corrosion was given to customers for 240 hours.

A corrosion test performed on five random samples, the results indicates that the required corrosion resistance to white corrosion which has been assigned by the customer. White corrosion was not observed on any test sample, so we can evaluate the galvanic zinc process to be successful.
